REPORT: FE-18-97

RAILROAD: Union Pacific Railroad Company (UP)

LOCATION: Portland, Oregon

DATE, TIME: June 24, 1997, 4:30 a.m., PST

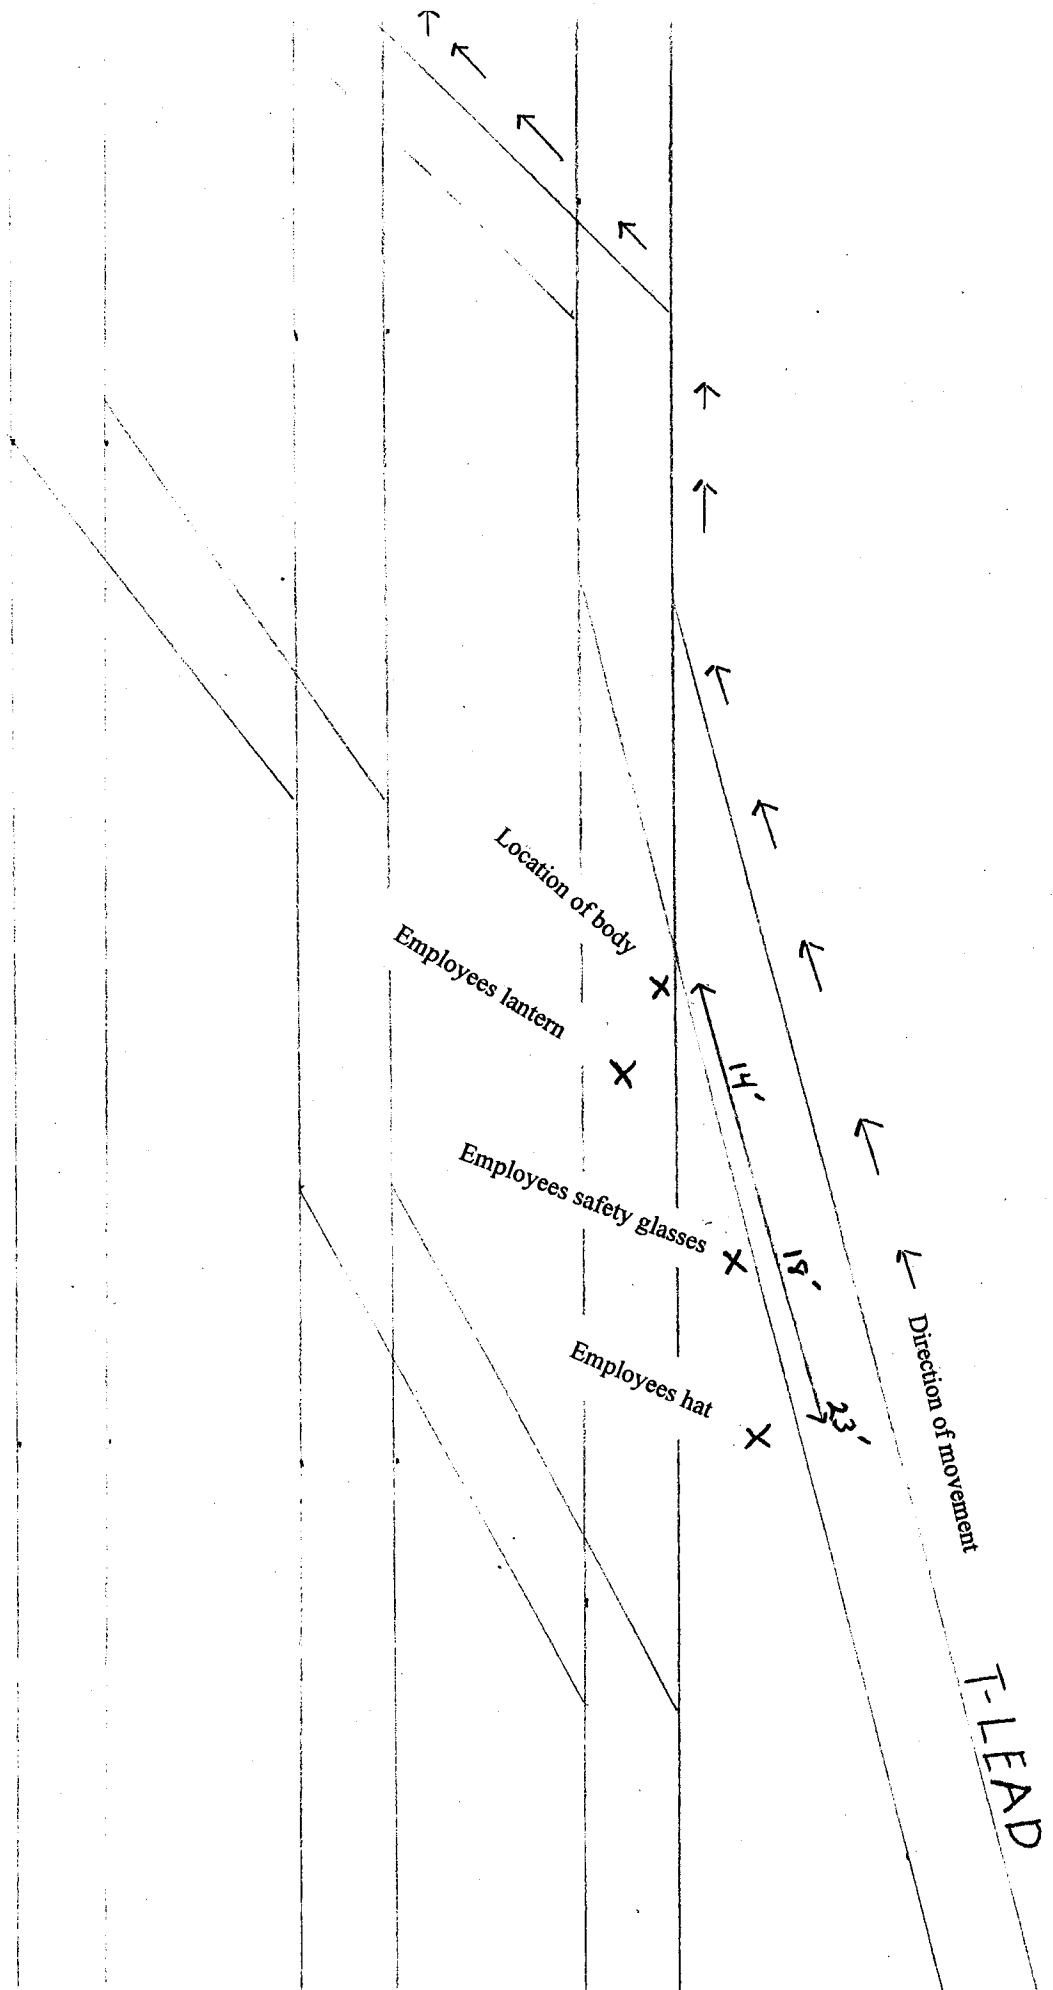
Please see the attached diagrams of Brooklyn Yard to better visualize the accident scene and chain of events that led up to the fatality.
